Case Study Beneficial Use of Sediments

| Project | <i>Brightlingsea Dredging and Restoration</i> |
| Classification | <i>R4B_2016_UK</i> |

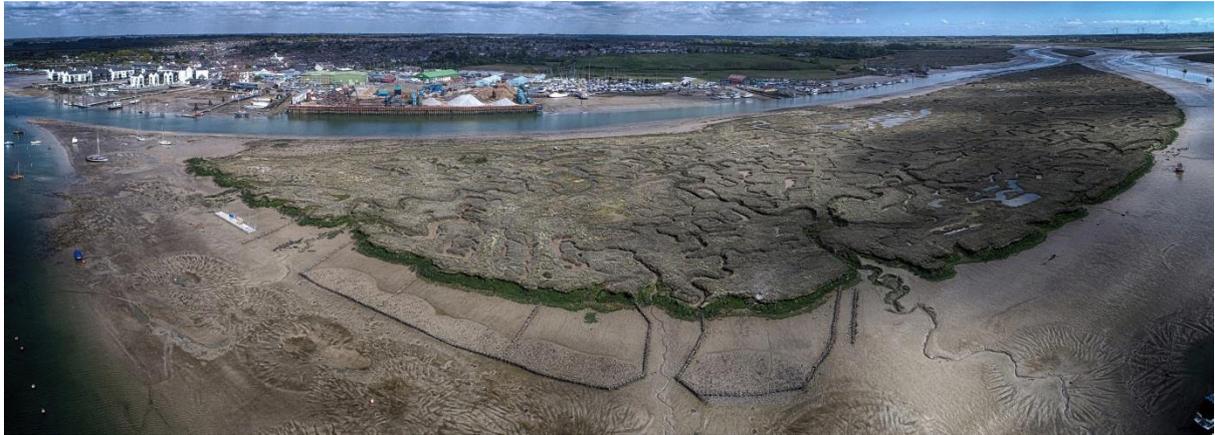
Figure 1. Aerial imagery of the Cindery West, west point Year 1 restoration site.

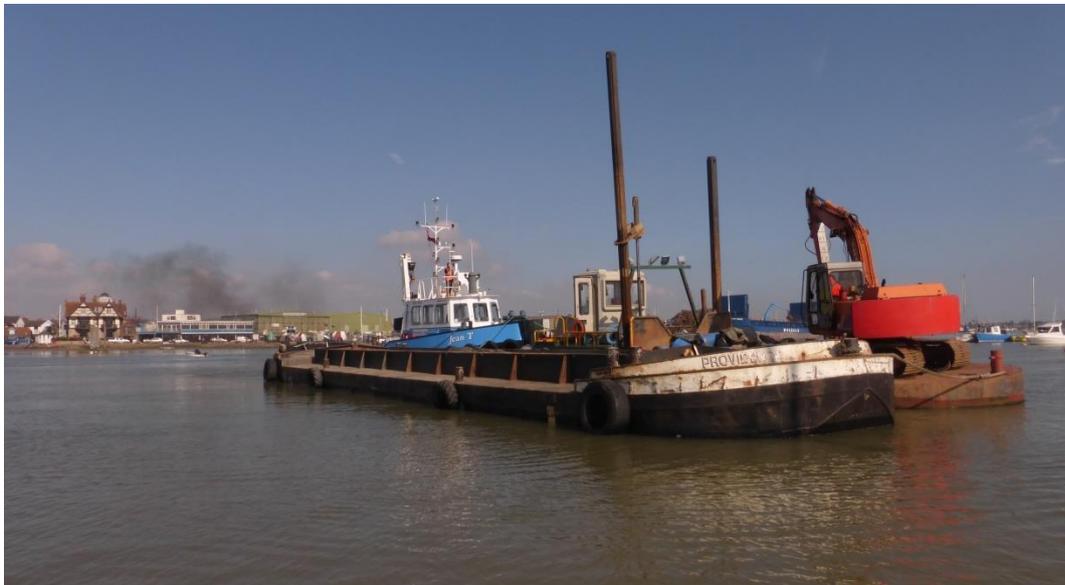
Figure 2. Mechanical dredging and hopper barge transport to the restoration compartments (Figure 1).
